HERMANTOWN ECONOMIC DEVELOPMENT AUTHORITY

A. Hwy 53 Business Park Desktop review and discussion of next steps.

The desktop review focused on available existing information containing relevant information on geotechnical and environmental conditions and related considerations for development of the business park. The desktop information review completed by Braun Intertec included the following:

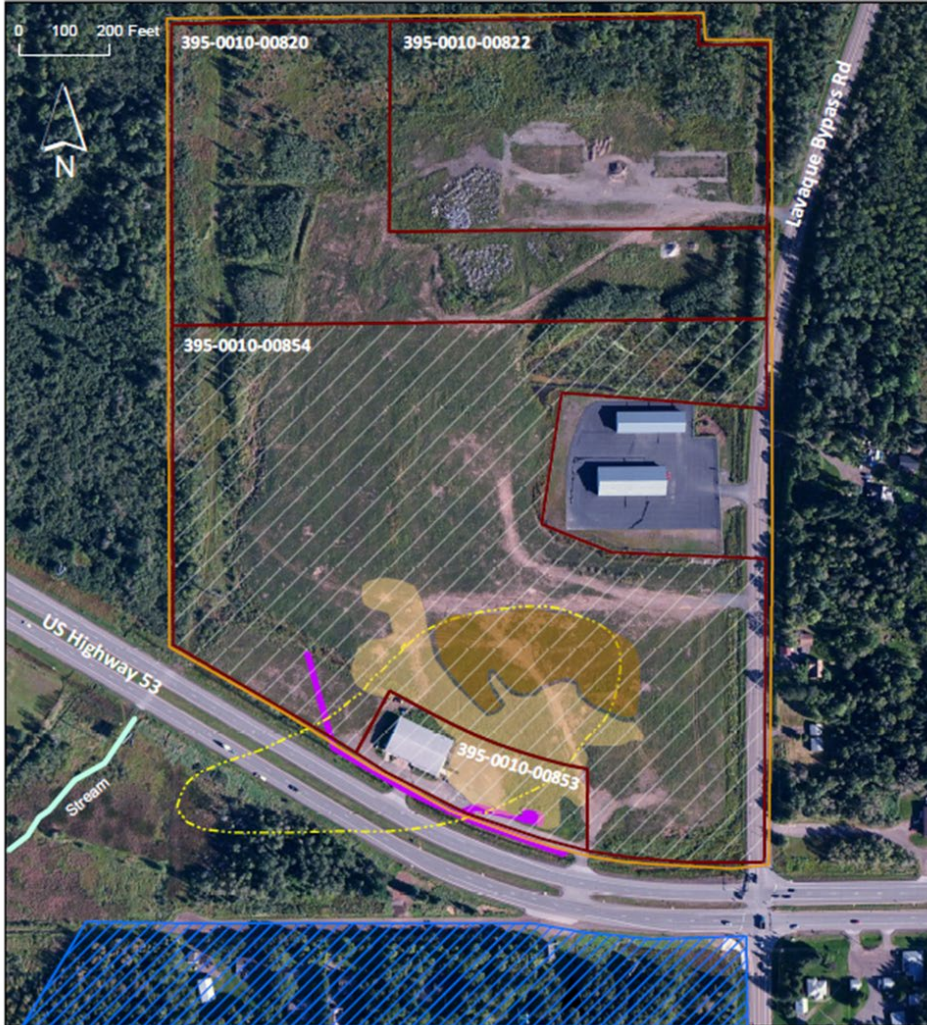
| Extent of soil excavation by USEPA (1996) | 1, 4-Dioxane estimated plume extent |
| | City water line extended and all homes hooked up in 1990 |

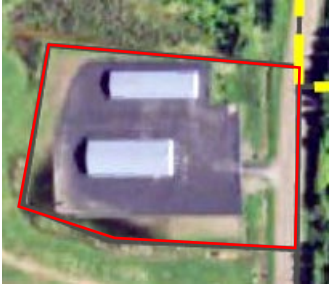
1940 Aerial Photograph	2013 Aerial Photograph

Year	Use	Source
1940 – 1997	The site is undeveloped and wooded.	Aerial photographs
2003	The site is undeveloped but is no longer wooded.	Aerial photograph
2008 – 2015	The site has been developed with two commercial buildings with paved areas.	Aerial photograph
2019	A third building has been added, along the southern edge of the site. Outdoor storage is visible around the buildings.	Aerial photograph

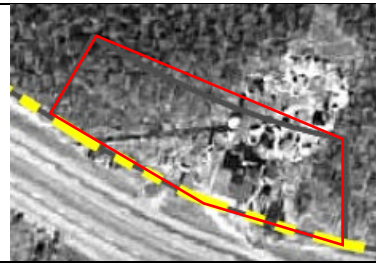
1940 Aerial Photograph	1953 Aerial Photograph

Year	Use	Source
1940	One small building is present near the southeast portion of the site. The remainder of the site is wooded.	Aerial photograph
1948	A drainage ditch or disturbed area is present on the south side of the site. The remainder of the site appears unchanged.	Aerial photograph
1951	The site is more developed with cleared areas.	Aerial photograph
1953 – 1961	The building has been expanded or replaced with a larger commercial building. The site is mainly cleared. Outdoor storage or dumping is visible along the northern portion of the site and onto the adjacent parcel.	Aerial photographs
1972	An additional building is present. Outdoor storage or dumping is still visible.	Aerial photograph
1975 – 1978	The buildings on the site have expanded or been replaced with larger buildings. An additional building is present along the southern portion of the site.	Aerial photographs

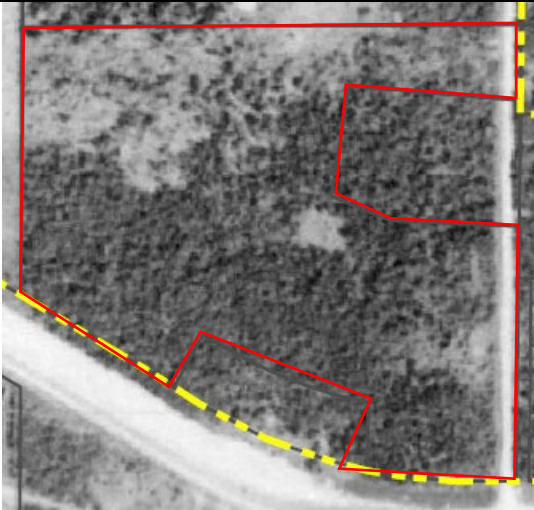
1940 Aerial Photograph

Year	Use	Source
1940 – 1951	The site is undeveloped and wooded.	Aerial photographs
1953	Some areas of outside storage or dumping are present. The remainder of the site appears undeveloped.	Aerial photograph
1961 – 1972	A lagoon or pond is present in the area where outside storage was previously noted. The remainder of the site appears undeveloped. By 1972, the pond area is larger and a small building is present.	Aerial photographs
1975 – 1981	The area of disturbance is larger and includes some areas in the center of the site.	Aerial photographs
1989 – 1991	The disturbed area appears more vegetated, and the building noted earlier appears smaller.	Aerial photographs
1997 – 2008	The southern and central portion of the site appear to have been graded and a road or ditch is present around some areas.	Aerial photographs
2013 – 2015	The road or ditch is no longer present and the site appears graded and vegetated.	Aerial photographs
