# **Appendix E:** *Species Reports*

**Project Name:** Hermantown Industrial

**Project Type:** Development, Commercial/Institutional/Industrial

**Project Description:** The study area is planned to be developed for a light industrial project.

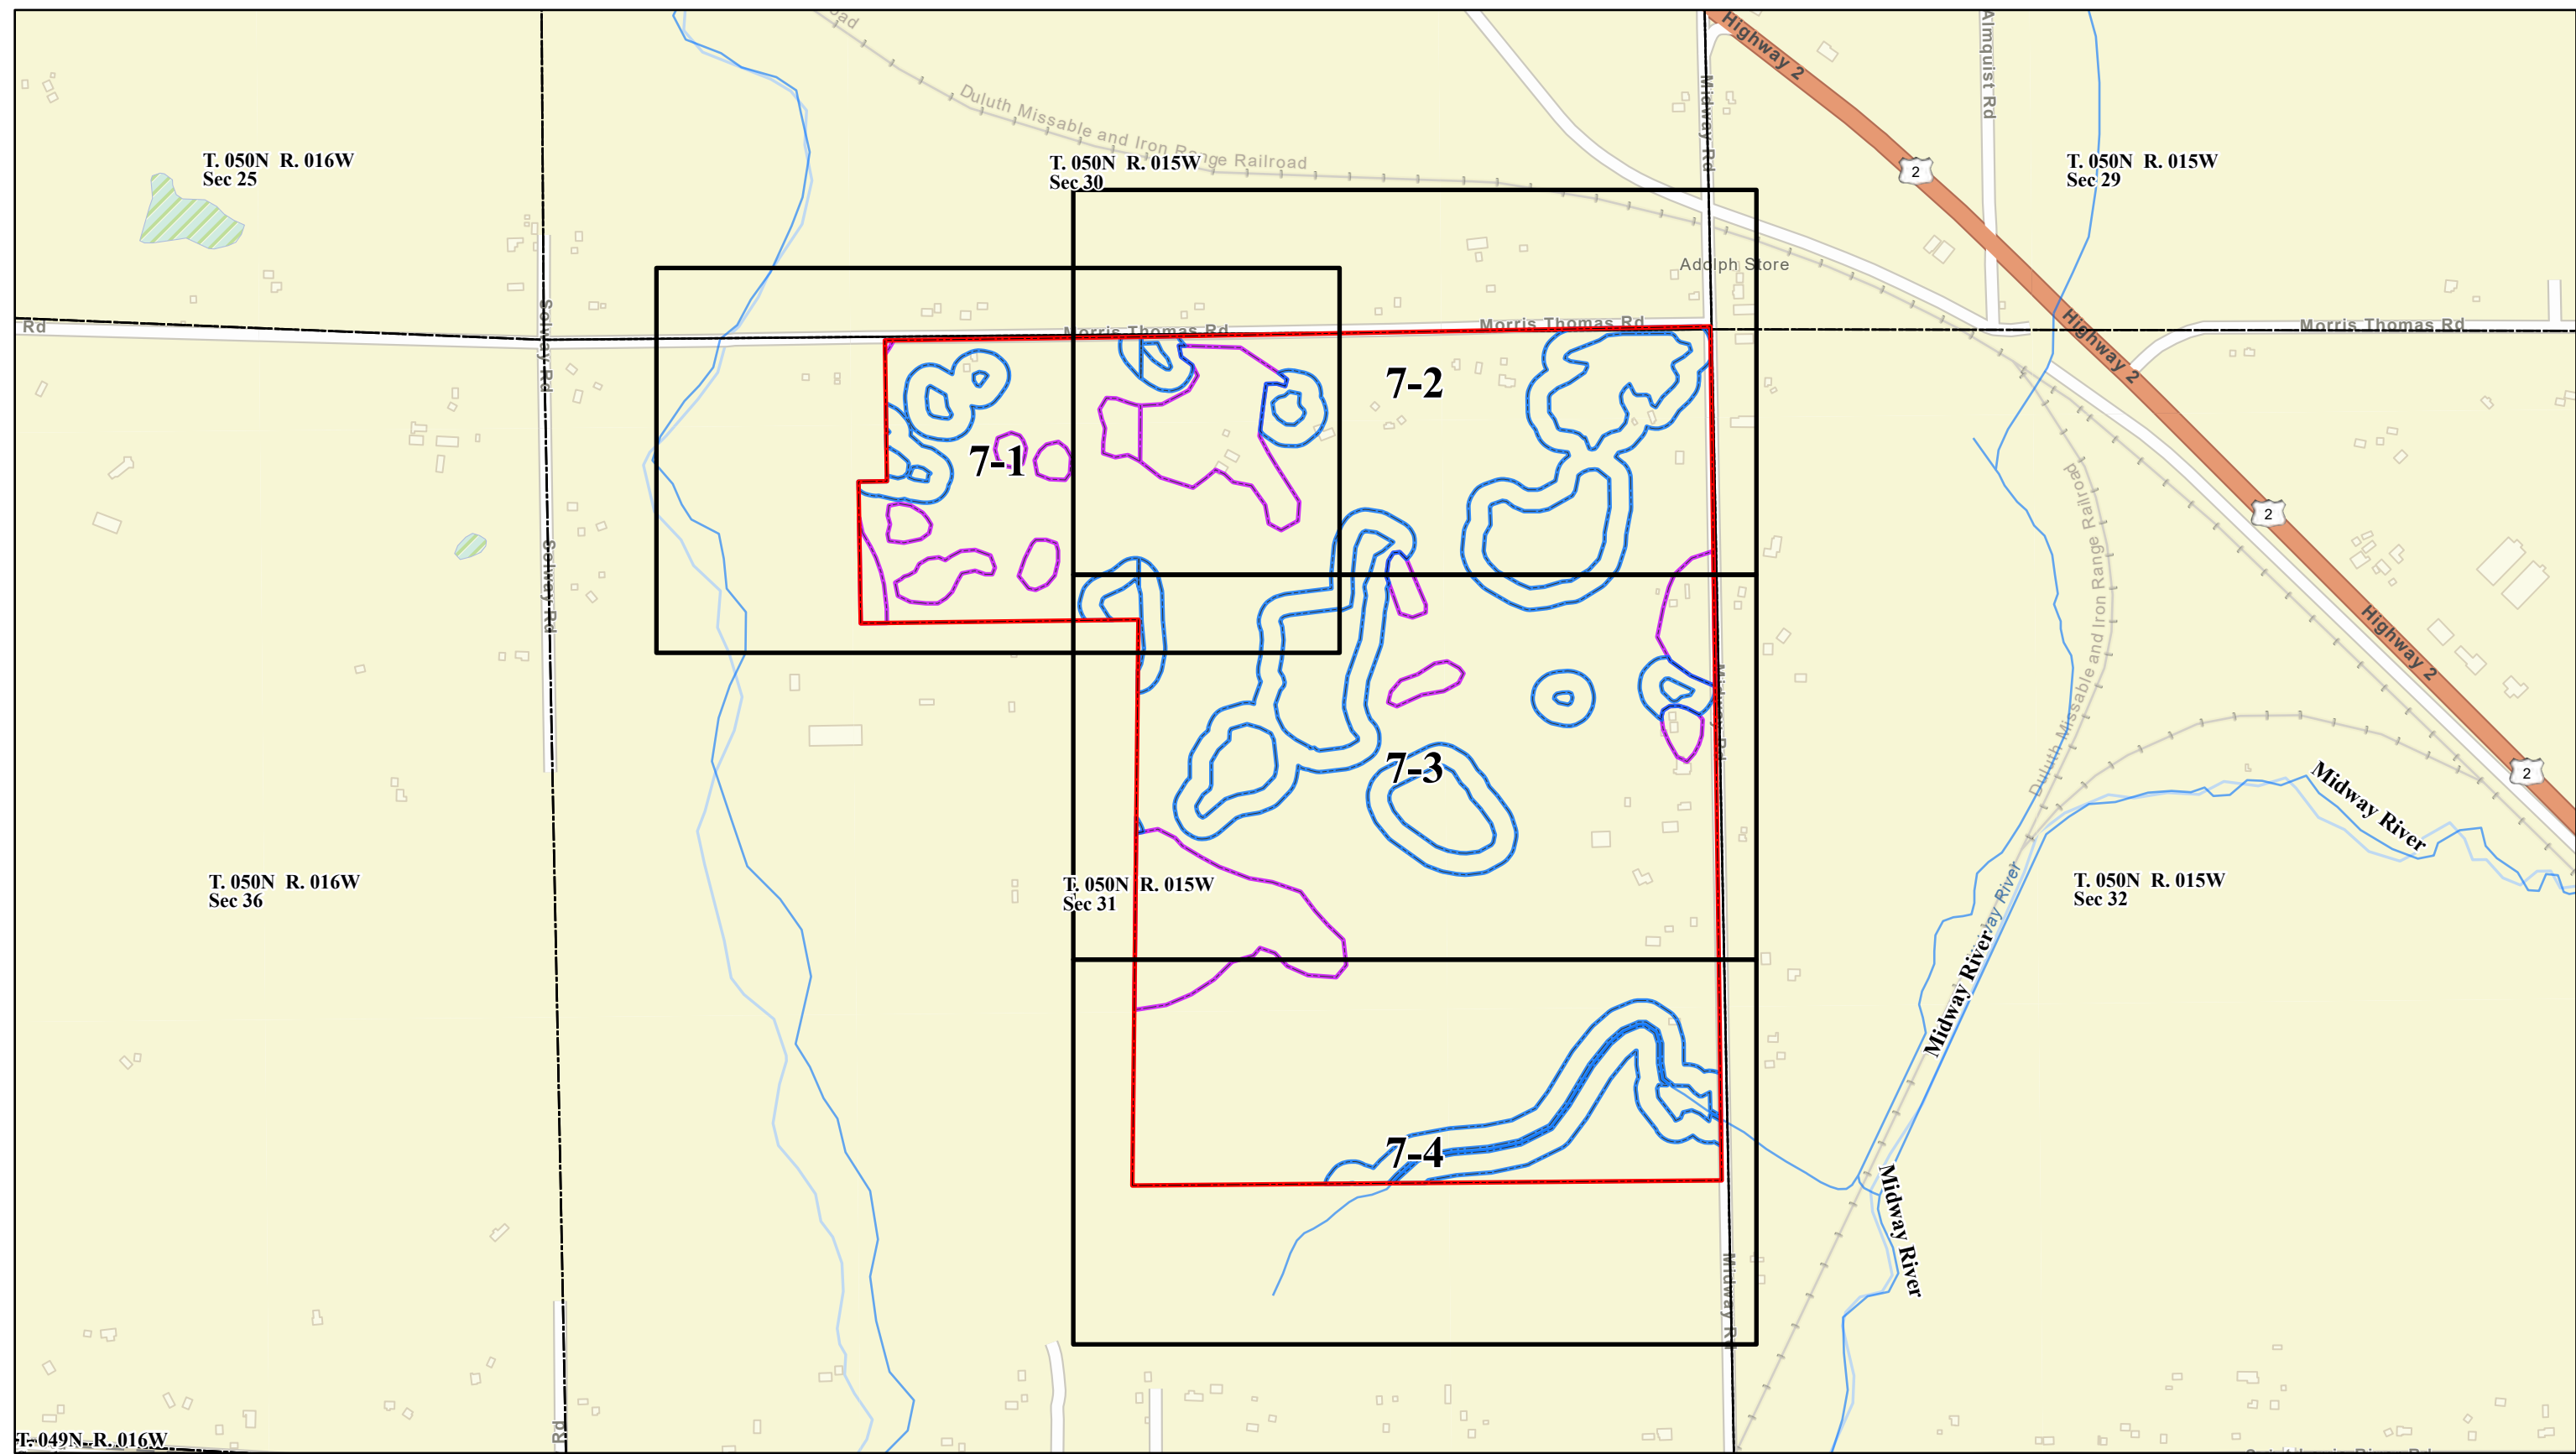
Note: Imagery courtesy of ESRI  
**Figure 6. Political map showing the mapbook layout for the fieldwork map of the project indicating the results of testing and photo orientations.**

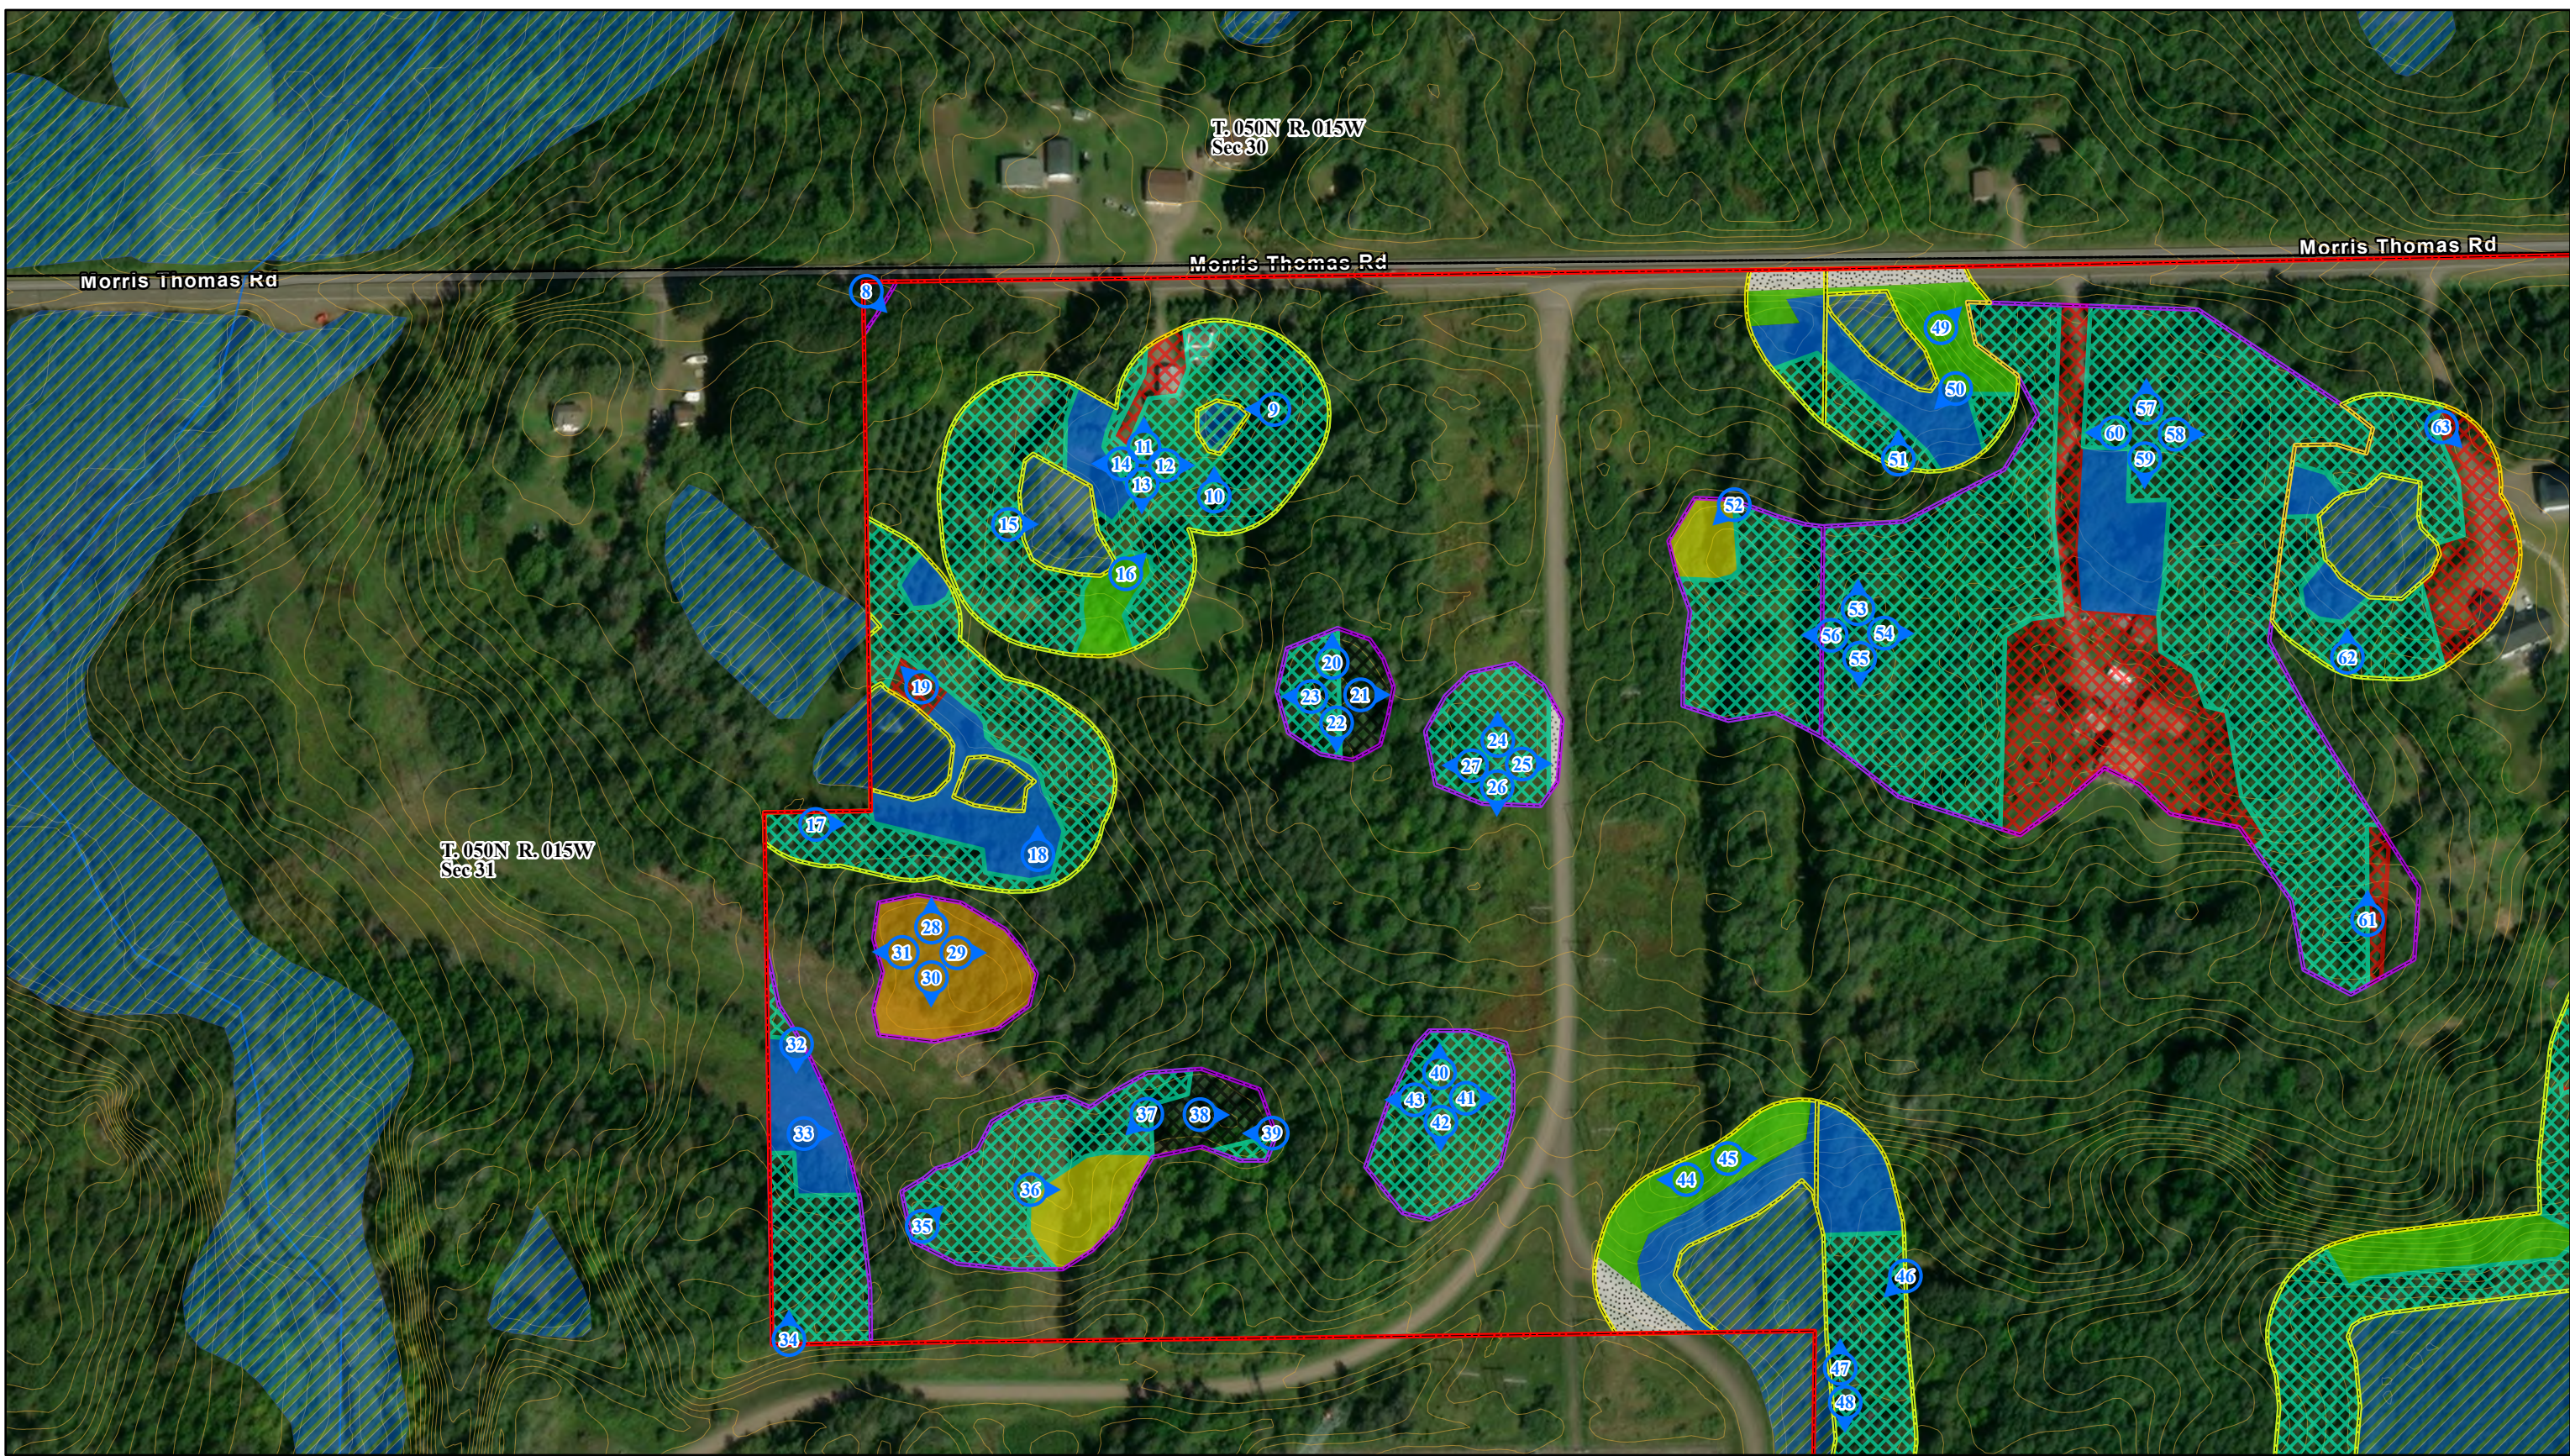
**Figure 7-1. Fieldwork map of the project indicating the results of testing and photo orientations.**

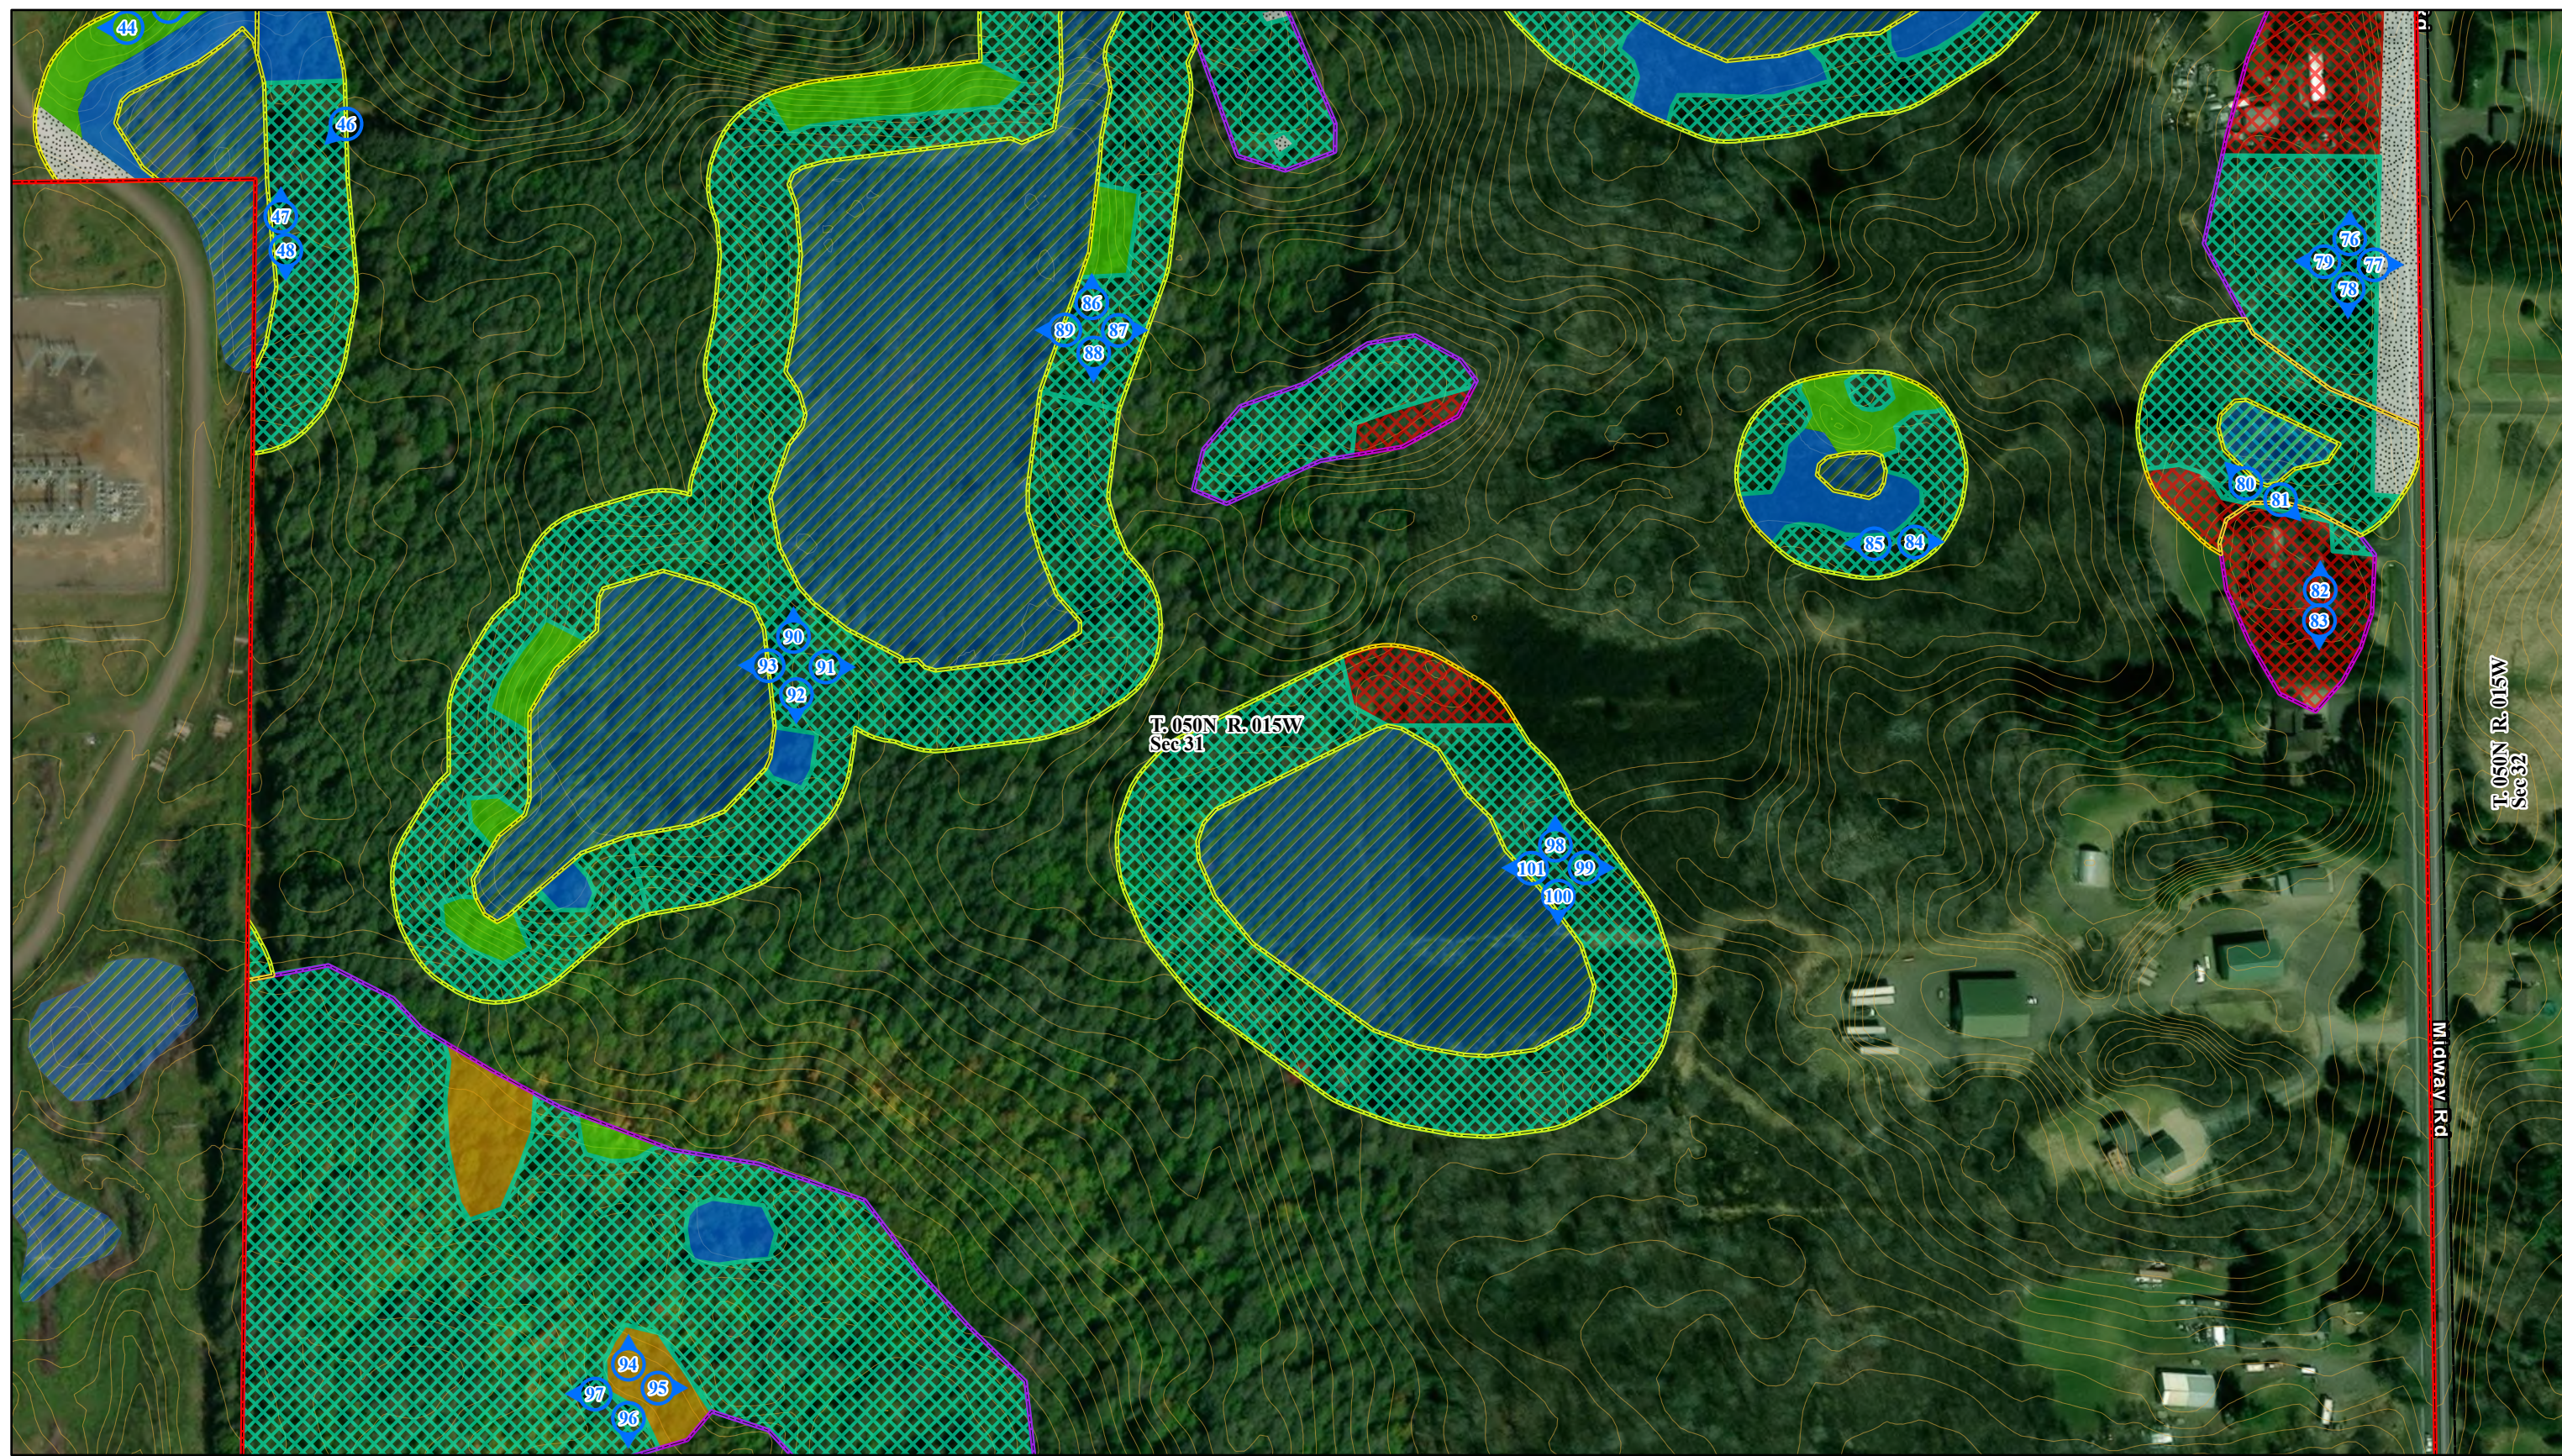
**Figure 7-3. Fieldwork map of the project indicating the results of testing and photo orientations.**

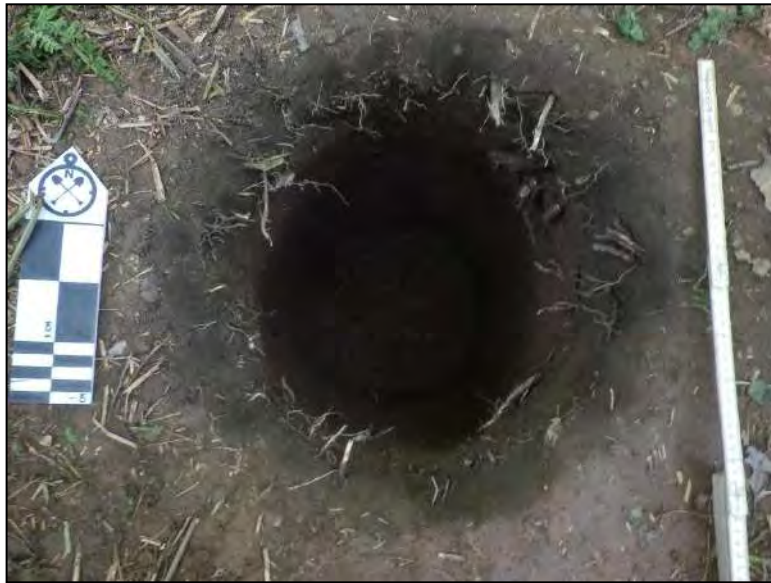
Representative shovel test photo.

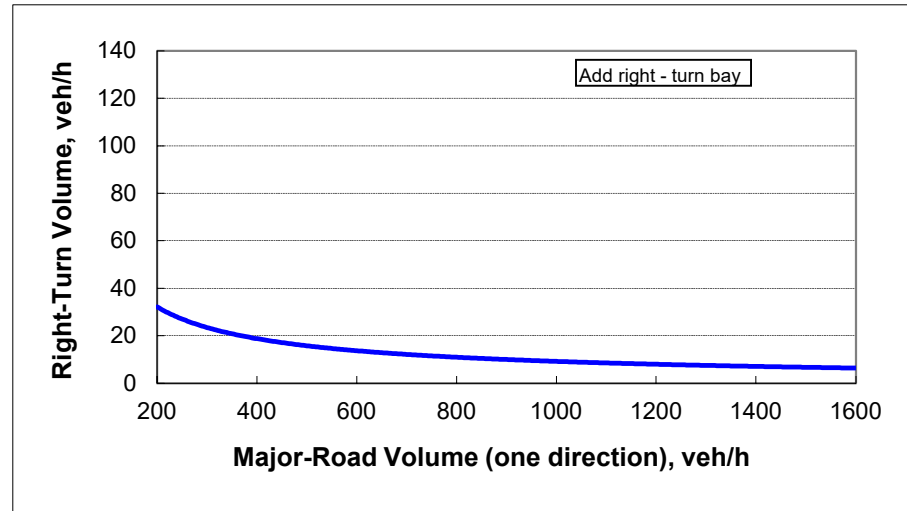
Morris Thomas Road & Industrial Access Eastbound Right (2045 Build Conditions)

Variable	Value
Limiting right-turn volume, veh/h:	51
<b>Guidance for determining the need for a major-road right-turn bay for a 2-lane roadway:</b>	
Do NOT add right-turn bay.

**Figure 2 - 5. Guideline for determining the need for a major-road left-turn bay at a two-way stop-controlled intersection.**

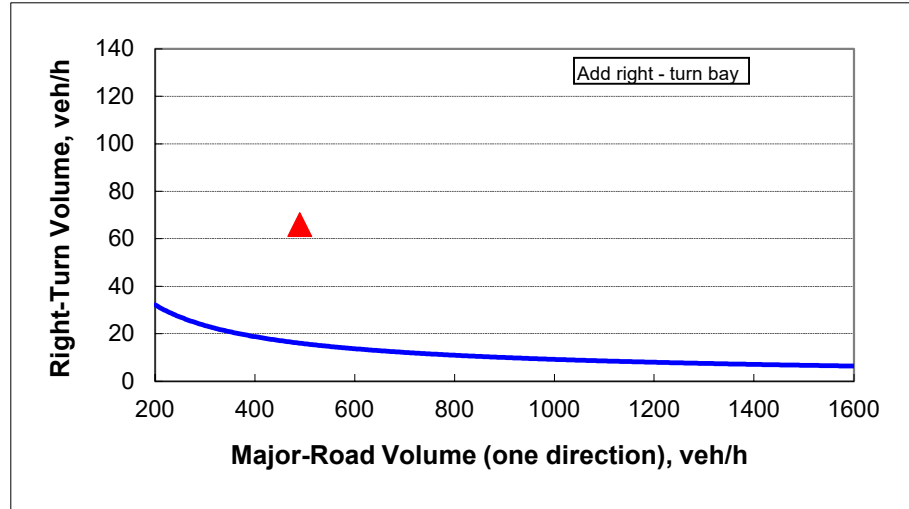
Midway Road & Morris Thomas Road Southbound Right (2030 Build Conditions)

Variable	Value
Limiting right-turn volume, veh/h:	16
<b>Guidance for determining the need for a major-road right-turn bay for a 2-lane roadway:</b>	
<b>Add right-turn bay.</b>

**Figure 2 - 5. Guideline for determining the need for a major-road left-turn bay at a two-way stop-controlled intersection.**
